**SOUTHWESTERN COASTAL BASIN
GREENWICH, CONNECTICUT**

**AMERICAN FELT DAM
CT 00043**

**PHASE 1 INSPECTION REPORT
NATIONAL DAM INSPECTION PROGRAM**

FEBRUARY, 1980

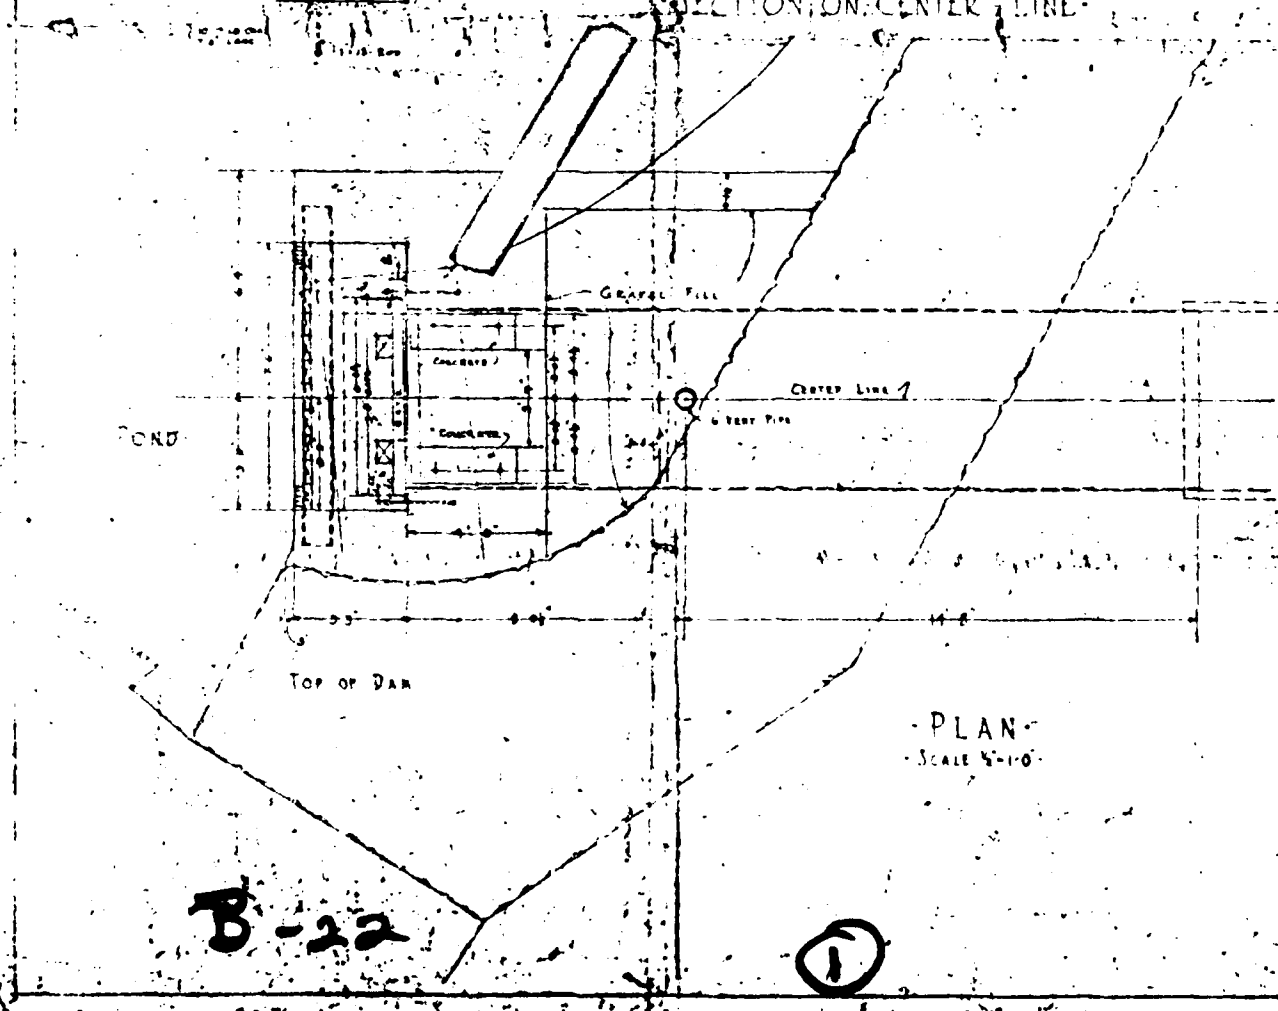
B-22

CRACK IN OLD PAVEMENT WITH SUBSTRUCTURE
ROAD. ALSO BY REPAIRING SPOTS AND FILLING
WITH CONCRETE 14-INCHES THICKNESS OF
PAVING TO 18-IN. RESTORATION AFTER WATER WAS
MOVED FROM POND AND FILLING CONDITION WAS
OF OLD PAVEMENT MORE ACCURATELY DETERMINED
DATE 1-24-5.
